Foggy Glass Disease.

Looking Through Hazy Windows.

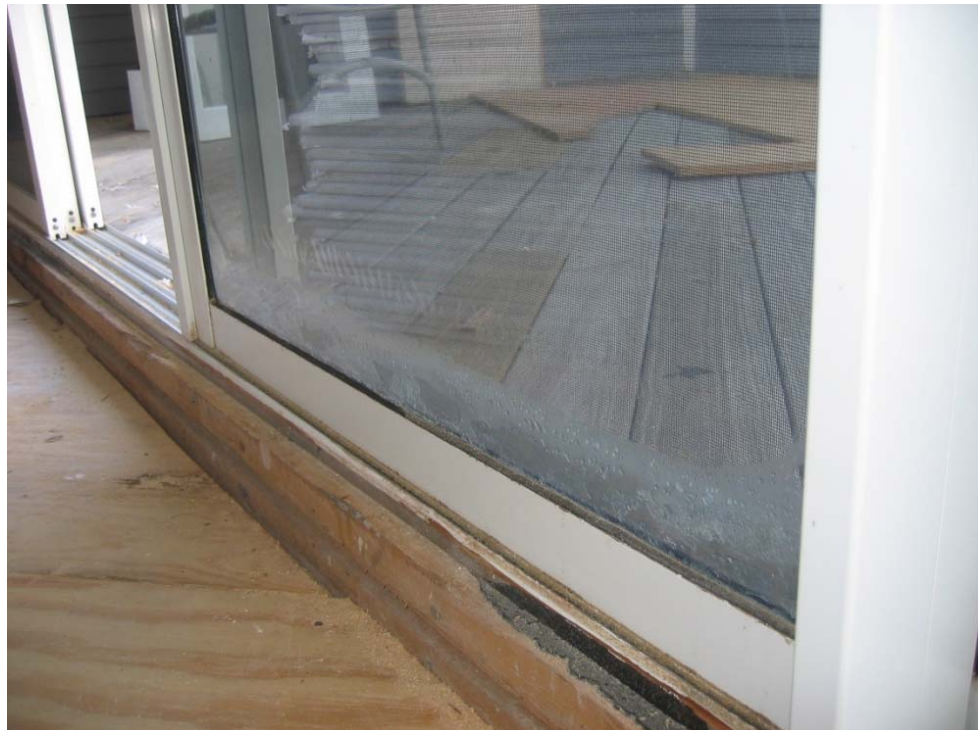
Figure 1: The widespread "Florida Glass Disease." Delamination of the PVB interlayer in an improperly designed framing.

Fogging and bubbling are typically found to be signs of failure of the laminate interlayer, often made of polyvinyl butyral (PVB). The failure occurs most often by chemical reaction caused by a direct physical contact of the glass interlayers' edge with substances such as water and solvents, including byproducts released during a curing process of almost all sealants. PVB moisture content of about 0.5% by weight is enough to cause loss of adhesion to glass.

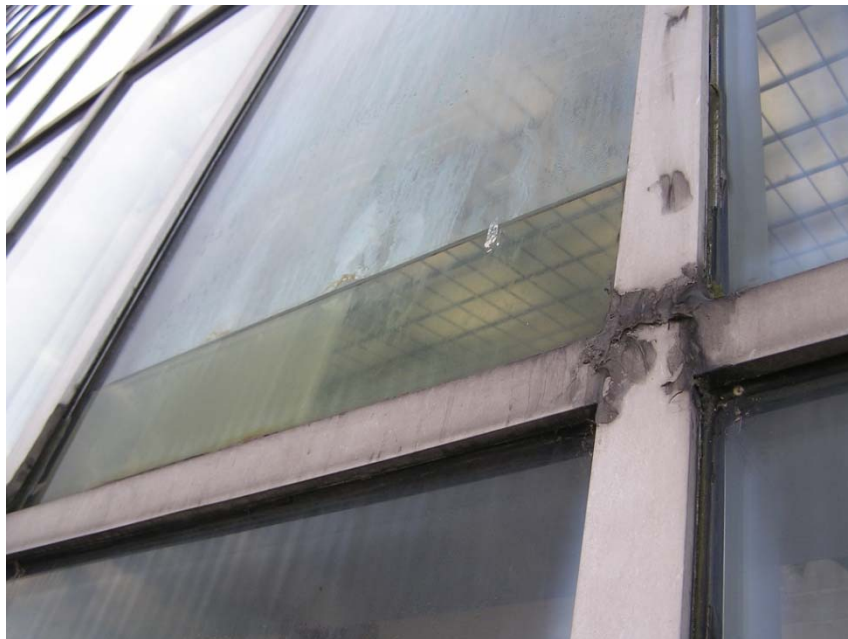
Figure 2: When all dams break loose, IGU may serve as an aquarium. The Metropolitan Museum of Art in New York City.

The mechanism is fairly simple. Haziness indicates presence of excessive volume of moisture in the cavity between glass layers. Moisture can enter the cavity in several ways, depending on the construction of the spacer and its seals. It's initially absorbed by the desiccant, and then the excess periodically condenses or freezes on cool surfaces. The failure is sometimes traced to the primary seal of glazing spacers. In a modern IGU, the longevity of the primary seal, typically made of a butyl sealant, depends on many factors, including exposure to shear stresses. And so, generally speaking, a well-made, conservatively framed, small-size, transparent window in a permanently shaded location would generally last longer than e.g., a large glass pane, dead loaded by its inner ply, installed as a spandrel and exposed to large temperature and pressure variations, which are all conditions known to increase shear stresses of primary seals.

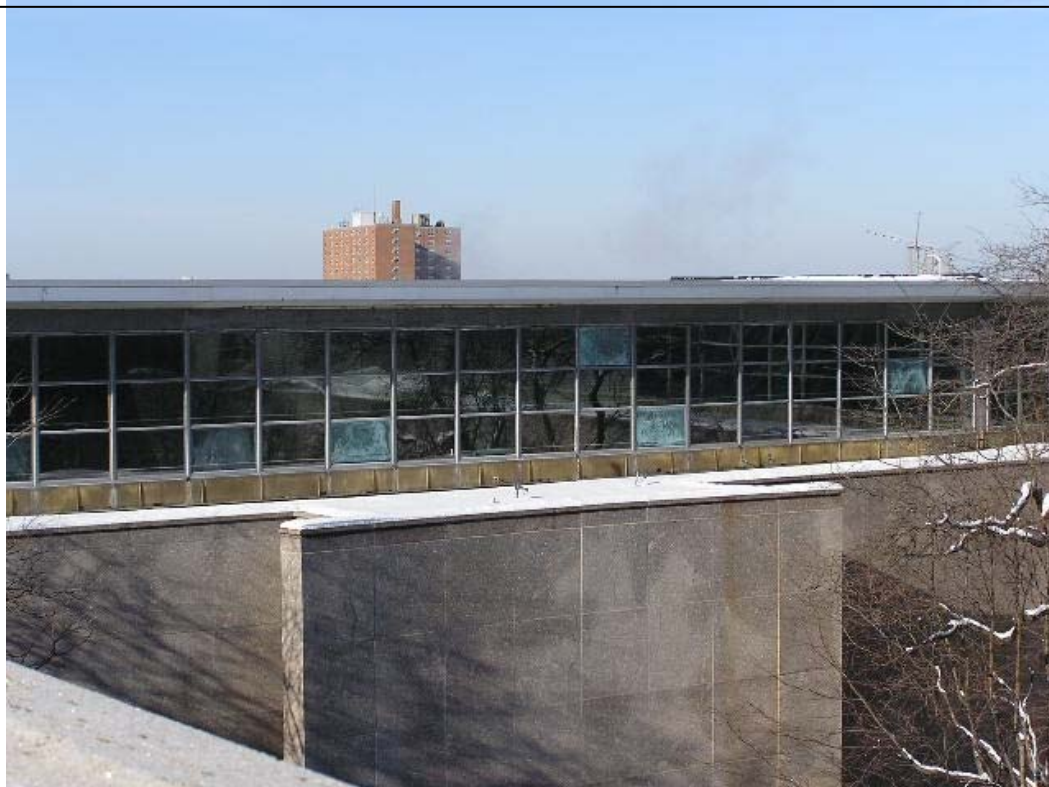
Figure 3: Frosting observed in failed insulated glass units on a facade. The Cleveland Museum of Art in Cleveland, OH.

If occupants find the hazy (and periodically frosted in cold and mixed climates) appearance objectionable, a questions "can it be repaired" is often asked. A foggy IGU can theoretically be repaired, but a careful

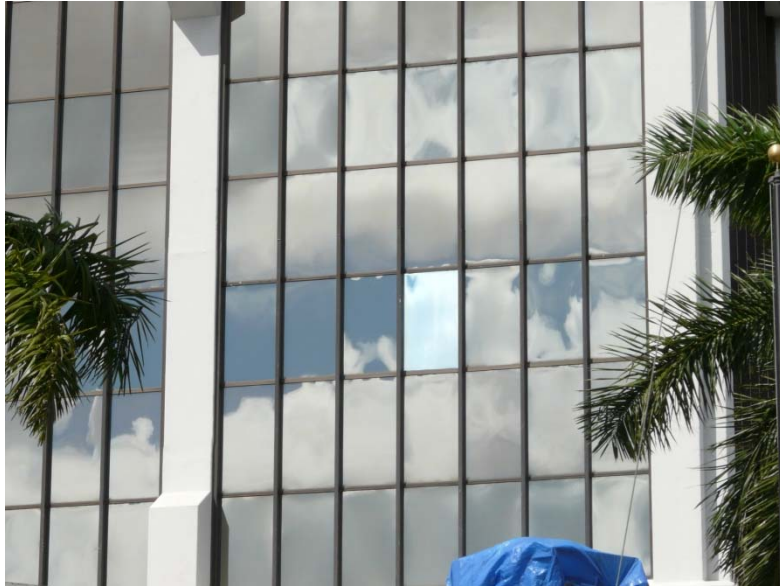
Figure 4: A typical glass mismatch caused by the lack of correct specification in a replacement glass procurement process. Miami.

Replacement of failed glass units may lead to the non-uniform appearance of a glazed facade. Due to the often widespread and systemic character of the failure, the blanket replacement is typically recommended. Matching of the glass appearance is challenging on aged facades and is recommended chiefly in case of a glass breakage, when the remaining glass has a high remaining technical life expectancy, or in a severe maintenance budget shortage situation.

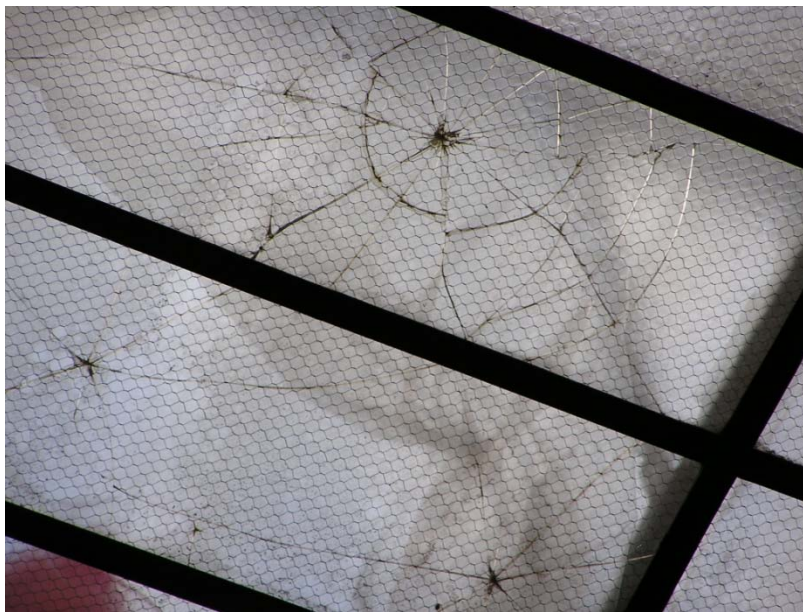
Figure 5: A laminated glass is intended to stay in frame when broken, replacing a wired glass previously used in such applications.

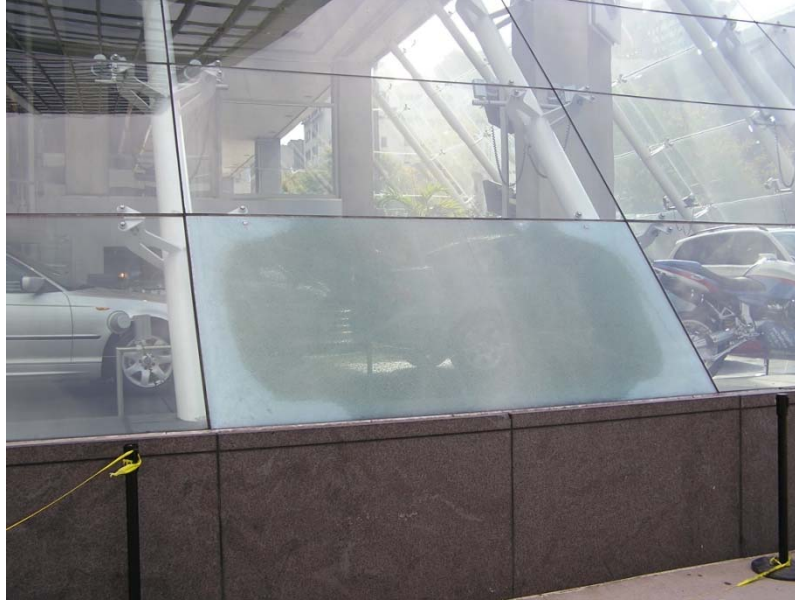
Figure 6: A laminated glass is intended to stay in frame when broken, and prevent simultaneous breakage of plies of glass. Glass laminate becomes foggy when stretched, indicating the areas stressed after breakage of both plies. New York City.

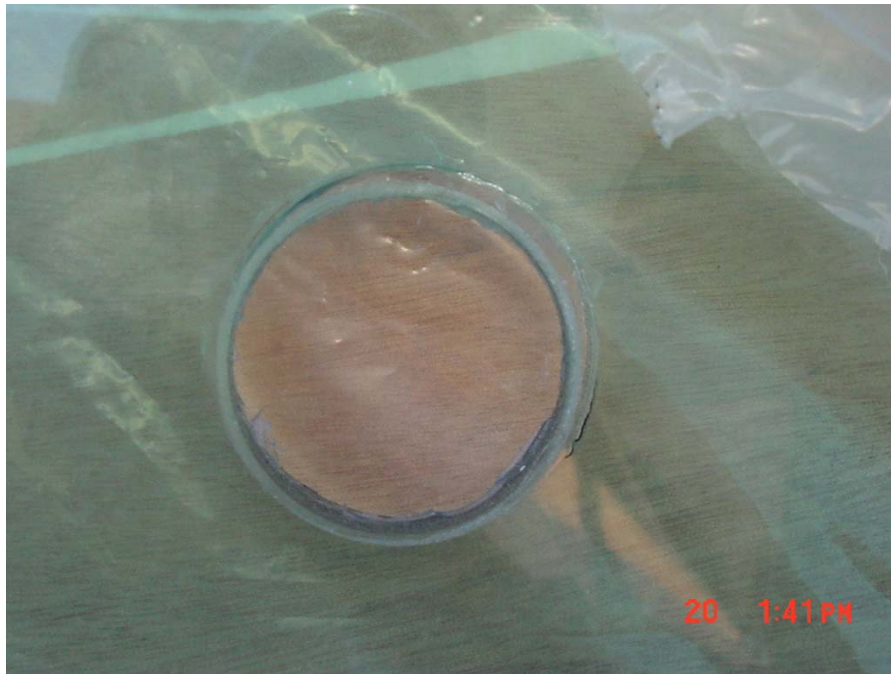
Figure 7: Laminated glass is characterized by poorer dimensional tolerances than other types of glass. However, this fact is seldom accounted for a glazing design when a standard framing is used, resulting in glass edge contamination.

As mentioned above, the replacement is very often futile without curing the underlying problem which typically lies within the surrounding glazing assembly. The most typical example is a recurring glass replacement undertaken in glazed doors and windows in which the edge of the glass is positioned in contact with a seal or water in an insufficiently wept framing. Such a replacement should be preceded by diagnosis of the underlying problem by a glass expert, and a subsequent re-design of the glass edge conditions in order to avoid the same problem reoccurring in the nearest future.
